# Reassessing an Early Medieval Rural Mosque in Al-Andalus: New Insights from Building Archaeology Analysis of the Cortijo de Las Mezquitas (Málaga, Spain)

Recent investigations at the Cortijo de las Mezquitas complex (Antequera–Campillos–Sierra de Yeguas, Province of Málaga, Andalusia, Spain) have focused on clarifying the construction history of the monument and on contextualising the presence of an early medieval rural mosque, a rare example within the Iberian Peninsula. The reassessment of the complex, conducted within the methodological framework of Building Archaeology, has made it possible to describe the constructive characteristics of the building with greater precision, both in terms of its architectural design and its construction process. This approach has enabled a more detailed definition of the technological context employed in the original construction phase, as well as of the chronological range to which it belongs, spanning between the late ninth and early tenth centuries. Subsequent phases of reoccupation and transformation, particularly from the sixteenth century onwards, were also documented, although the dating of some interventions remains uncertain. This re

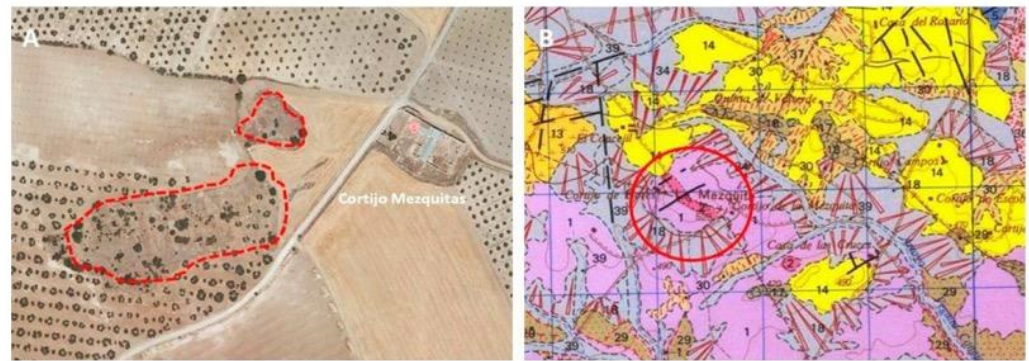
**Figure 5.** (A). Dolomite, limestones and carniola outcrops (Iberpix, IGN). (B). Geological map of the Cortijo de las Mezquitas area, with outcrops of variegated clays and sands in purple, and outcrops of dolomite and dolomitic breccias in red (Antequera Sheet 1023, IGME).

The province of Málaga is located south of the Subbética Mountains, an area composed of Triassic and Meso-Tertiary rock formations (Figure 4). In this geological context, the Cortijo de las Mezquitas sits on outcrops of variegated clays, marls, sands and gypsum, and calcareous materials, such as dolomite, dolomitic breccias, limestones and carniola, which are arranged in small outcrops in the vicinity of the complex (Figure 5).

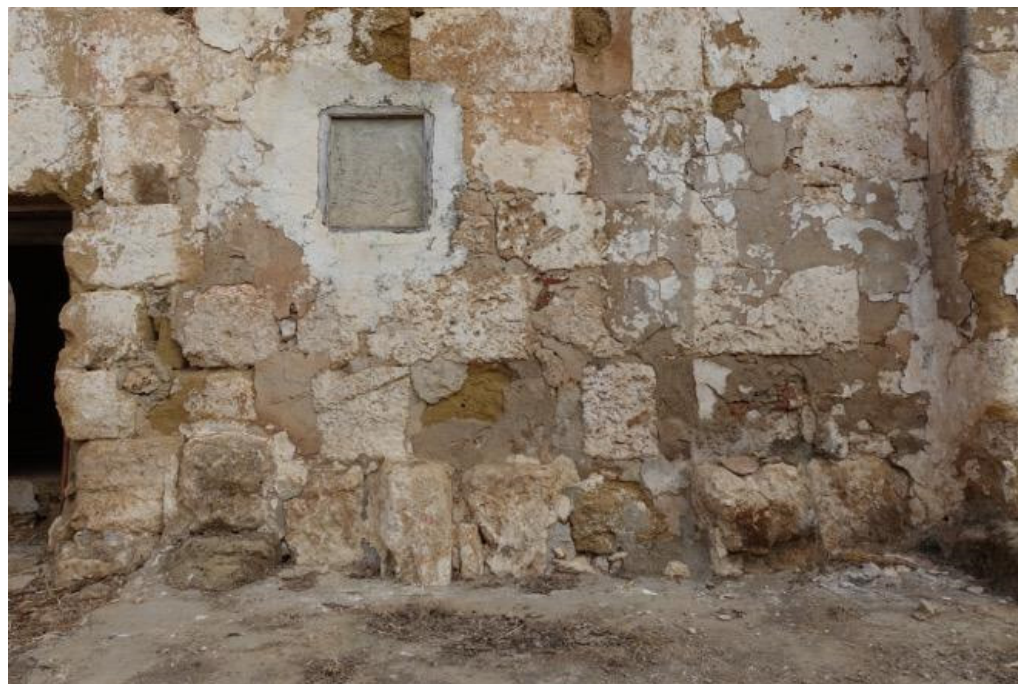
**Figure 6.** Lower course (A101, SU1012) and elevation of the southeast front (A102, SU1001) of the main hall (Stage 3). Window put in later (Stage 6, A128, SU1015). For stratigraphic sequence see Figure A1.

The analysis began with the exterior of the southeast façade (SU1001, Figure A1). In this elevation, between the third and fourth buttresses from the west, a masonry course (A101, SU1012, Figure A1) approximately 50 cm in height is visible, projecting c. 25 cm from the wall face. It consists of ashlar blocks of irregular arrangement, lithology (oyster stone and limestone), and size (Figure 6). These blocks present a regular outer face—though some protrude more than others—and their joints are filled with fragments of masonry, brick and tile. Similarly, on the east side of the second buttress, another limestone block can be observed protruding from the wall line (thickness: 53 cm; height: 25 cm; projection: 62 cm). The use of cement and later limewash layers (Phase 6 and 7) prevents more precise characterisation of these elements, making it uncertain whether they relate to the foundations of the building, to an earlier structure or to later reinforcement works. This possibility has been proposed by Oliver León [12] (p. 39), according to the excavation of this area during the consolidation works of 2015. For this reason, they have been differentiated from the rest of the original fabric. Only direct intervention on this section, removing the layers that cover it, of the elevation may help determine which of the three hypotheses is correct.

The ashlar is mostly laid in the stretcher position (maximum length: 80 cm), and the course heights range between 40 and 50 cm (Figure 6). The few headers used (length: 35 cm) coincide with the presence of interlocking features that facilitate the bonding between blocks and which, due to their regular spacing, may correspond to construction joints. Those blocks that have not been eroded show clear evidence of adze tooling, with slightly curved, through-running marks (often shared by several ashlar), applied in a fan-shaped pattern. Though not fully dressed, some blocks were nonetheless incorporated into the masonry. No putlog holes have been identified, although their absence does not exclude the use of scaffolding in the construction of these ashlar walls. The joints between the ashlar are extremely fine, and traces of a lime-rich, very hard, fine-grained mortar can be observed.

The conversion of this extensive southwestern sector of the former mosque hall into a domestic environment involved the insertion of two windows (A128), one in the southeast elevation (SU1015, Figures 6, A1 and A5) and another in the southwest elevation (SU1032, Figure A2). Both are small, rectangular and positioned at a similar level, suggesting their simultaneous use. In the same southwest wall, an additional window (A134, SU1031, Figure A2) was opened to provide light to the area beneath the staircase, although it is not possible to determine precisely when this was undertaken. The window (A133, SU1024, Figures A1 and A5) located in the rammed earth wall, representing the raised section of the southeast house (A113) described above, may also date to this phase. Its timber frame, now lost, was secured using a light-coloured earthy mortar.

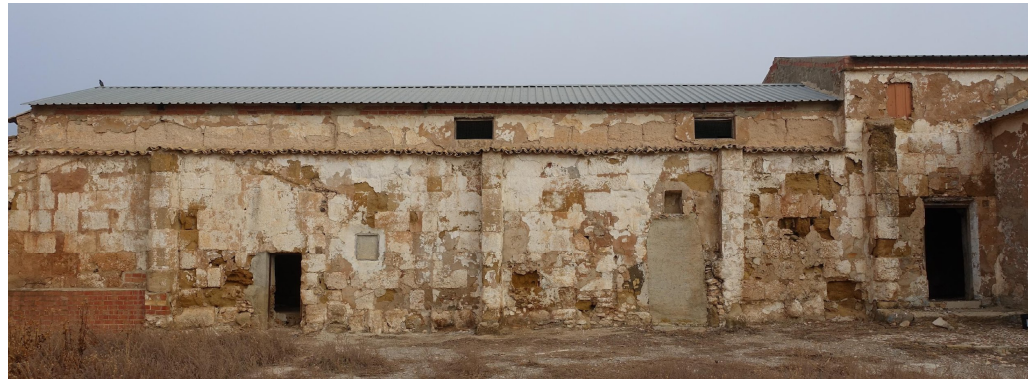
**Figure 7.** Southeast elevation of the main hall (Phase 3, A102, SU1001); collapse of the upper part of the walls (Phase 4, A108, SU1005); opening of the access door to the southeast house (Phase 6, A121, SU1002); destruction of the mihrāb (Phase 6, A120, SU1008); and raising of the hall (Phase 6, A114, SU1007). For stratigraphic sequence see Figure A1.

The southeast elevation (SU1001, Figures A1 and A5) stands on a continuous plinth of a single course, now almost entirely lost (Figure 7). Originally, it had eight buttresses (40 cm in depth, 50 cm in thickness). While the one located at the southern corner projects

Access to this southeastern house is gained from the south courtyard via a doorway and a step (A121). The doorway (SU1002, Figures A1 and A5) cuts through the original wall, with jambs constructed of masonry bonded with pinkish mortar and a lintel composed of two minimally worked timber beams (Figure 7). The opening measures 2.30 m in height, with an internal width of 1.21 m and an external width of 1.41 m. To bridge the difference in ground level with the courtyard, a step (SU1003, Figure A1) built of calcarenite ashlar blocks was installed. Simultaneously, this section of the south courtyard was levelled with a pavement made of river pebbles and solid brick fragments, framed by a continuous border of 15 cm high limestone slabs, forming a quarter circle. The doorway remained in use following the addition of the southeast annex (A115) and the elevation of the southeastern house (A113), both of which will be discussed below. A recessed rectangular panel above the opening once housed an exterior image. Martínez Enamorado [3] (p. 83, Figure 34) reproduces a colour photograph in which the rectangle of tiles with a possible virgin can be seen above this lintelled entrance. The entire structure is rendered in whitewash, with the exception of the lower plinth, which is painted blue. These finishes may date from a considerably later period.

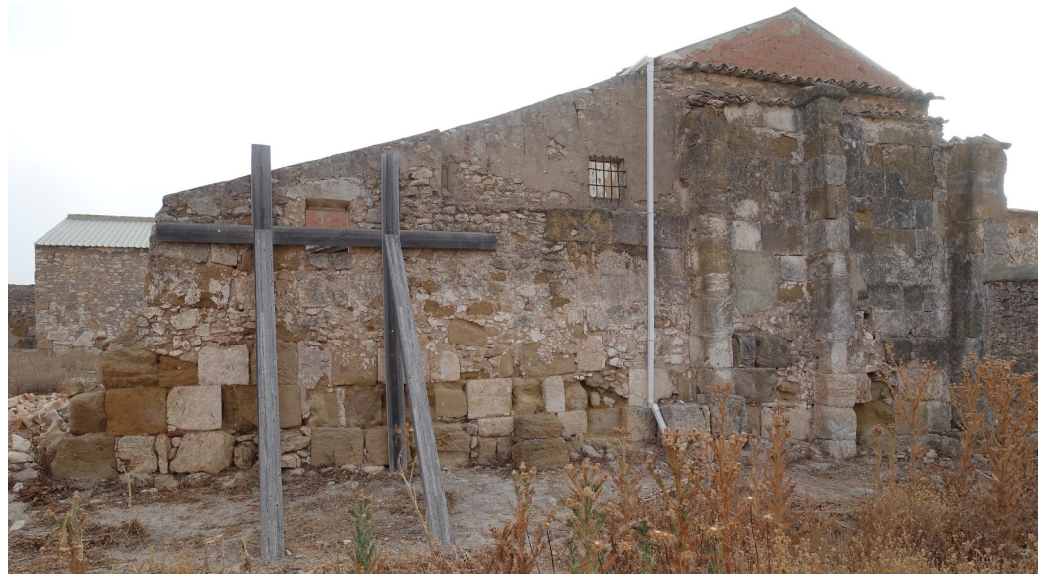
**Figure 8.** Southwest front of the main hall (Phase 3, A102, SU1025), ruin of the latter (Phase 4, A107, SU1037), and south house of the central courtyard (Phase 6, A117, SU1040). For stratigraphic sequence see Figure A2.

The southwest wall (SU1025, Figure A2) features a considerably higher plinth, composed of four courses (maximum height: 1.90 m; depth: 25 cm), and was reinforced with at least four additional buttresses (depth: 45–48 cm), each also provided with its own plinth (Figure 8). The buttress at the southern corner is shared with the southeast elevation, as previously noted.

The collapse of the northwest bay (A107) led to the loss of a large section of the southwest façade wall (Phase 3, A101, UE1025), specifically the stretch that closed off the central courtyard on that side (SU1037, Figures 8 and A2). The absence of buttresses on this wall and the downward slope of the terrain in this direction may have facilitated its collapse. The T-shaped pillar (Phase 3, A106, SU1064) from which the wall or arcade parallel to the aforementioned southwest wall extended was also dismantled (SU1074, Figure A7), possibly deliberately, as suggested by the chisel marks on the projecting ashlar. However, the collapse and dismantling may have occurred successively over time. The same process (SU1075, Figure A7) affected the western corner (Phase 3, A106, SU1067).

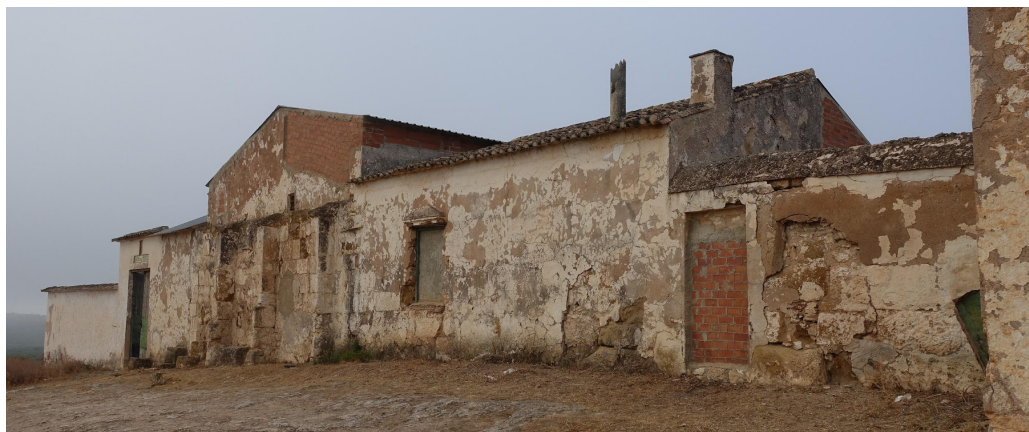
**Figure 9.** Northeast elevation of the main hall (Phase 3, A102, SU1041) and continuation of the structure to the north (Phase 3, A102, SU1048). For stratigraphic sequence see Figure A4.

The northeast elevation (SU1041, Figures A4 and A8) was reinforced with at least four buttresses, which are not symmetrical to those on the southwest described above, and included a substantial ashlar base along its southern half, between the first three buttresses (Figure 9). This plinth reaches a height of 1.75 m and, although it was later chiselled back, the remains of its projecting ashlars are still visible on the face of the wall.

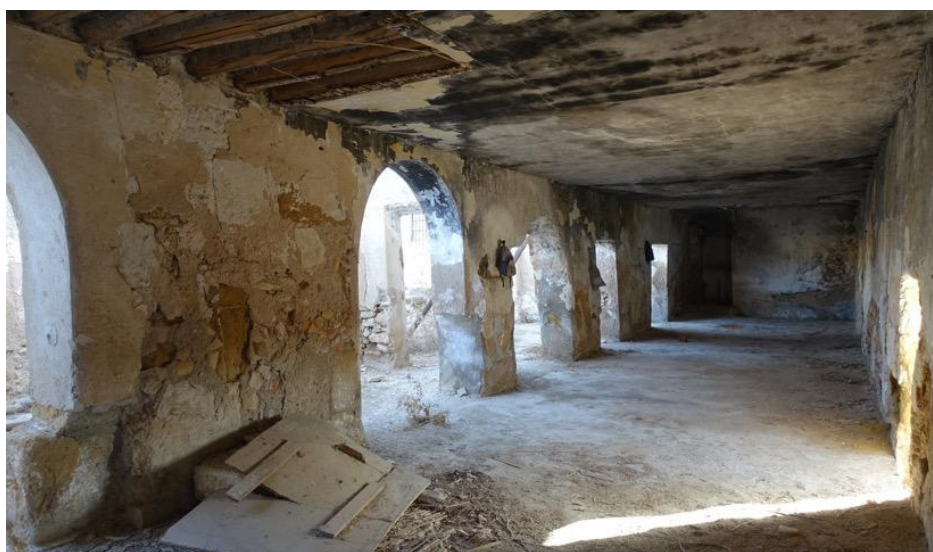
**Figure 10.** Interior of the southeast nave, view from the south, and arcade separating the parallel nave (Phase 3, A102, SU1077). On the right, original lintelled opening in the wall.

Inside, the main body of the large rectangular hall was divided into two naves by an arcade parallel to the southeast perimeter wall (SU1077, 1080, 1081, 1087, 1089; Figures A6 and A9). Another arcade on the northwest side (SU1092, Figure A9) served as a façade opening onto the central courtyard. Both arcades are currently highly fragmentary. The first section (SU1077) of the interior arcade is preserved (Figure 10). It consists of three piers supporting two horseshoe arches whose lower thirds and *salmeres* (springers) have, however, been hacked away. The piers have regular dimensions (89 cm in length, 64 cm in thickness) and are built of sandstone and limestone ashlars, sharing the same characteristics as the walls (horizontal courses, heights of 46–52 cm, irregular alternation of stretchers and headers). They are constructed as a single, 64 cm-thick leaf. On the westernmost pier, at a distance of 1.45 m above ground level and 24 cm from the perpendicular façade wall (SU1025), the carved frame of an *alfiz* (5 cm deep) is visible, which originally extended across the entire northwest elevation (Figures 11 and A6). This frame is partially visible on the other piers (as a horizontal notch), and also on the southeast face of the piers where it appears with the same dimensions. The last ashlar in the lower course of this first western pier bonds with the façade wall (SU1025, Figure A9), a relationship that confirms the contemporaneity of the wall and the arcade.

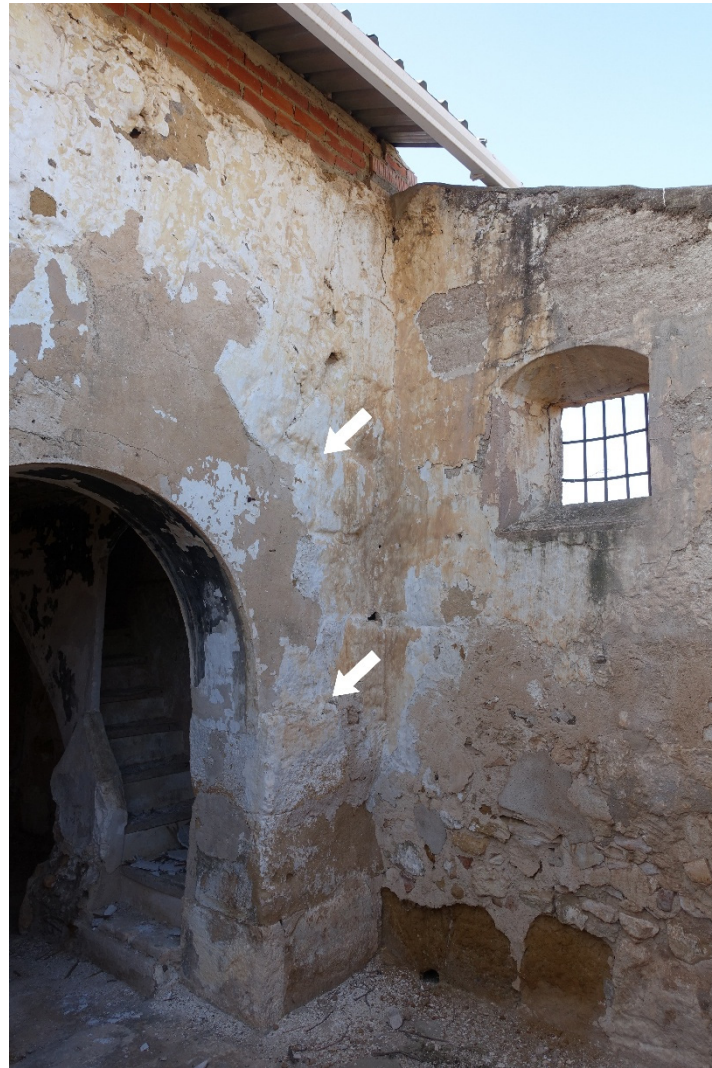
**Figure 11.** Junction between the interior arcade of the hall (Phase 3, A102, SU1077) and the southwest façade wall (Phase 3, A102, SU1025); remains of the carved *alfiz* in the corner, pointed by the arrows.

The arch rings are formed from a springer and two horizontal courses, with only the central voussoired section functioning as the actual arch. Only the second pier stands out in terms of length (2.20 m), being significantly longer than the others (90 cm). Moving northeast, only the three lowest courses of the third (SU1080), fourth (SU1081) and fifth (SU1087) piers are preserved—those situated below the horizontal notch of the *alfiz*. An ashlar projects from the southeast face of the fifth pier, giving it a T-shaped plan and thus explaining why it is longer than the others.

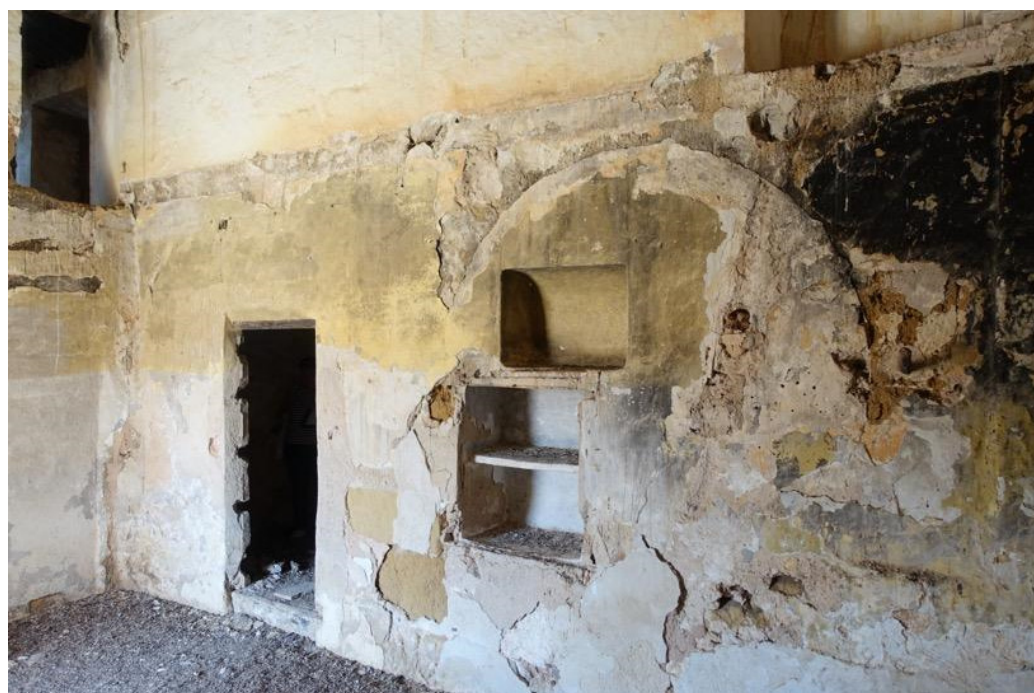
**Figure 12.** Section of the interior arcade preserved in the southeast house (Phase 3, A102, SU1089) and remains of the *alfiz* at the junction with the later perpendicular wall (Phase 6, A112, SU1097, 110).

The arcade continues in the northeast section of this structure (Figure A6), now part of a detached house (Figure 12), whose southwest dividing wall coincides with the original partition that may have extended from the last pier described (SU1087). As at the western end, two arches with an *alfiz* frame (SU1089) and two piers of the same dimensions (90 cm in length, 65 cm in thickness) and construction as those described in the other section are once again preserved at this eastern end. It should be noted that, at the junction between the arcade and the southwest dividing wall of the present house, the vertical rebate of the *alfiz* frame is visible, along with two additional ashlar that reinforce it. These features—together with the projecting ashlar on the opposite face of the same wall—indicate the presence of an internal partition (Figure 11). In other words, this pier would have had a T-shaped plan, and the southwest wall of the current house would fos-

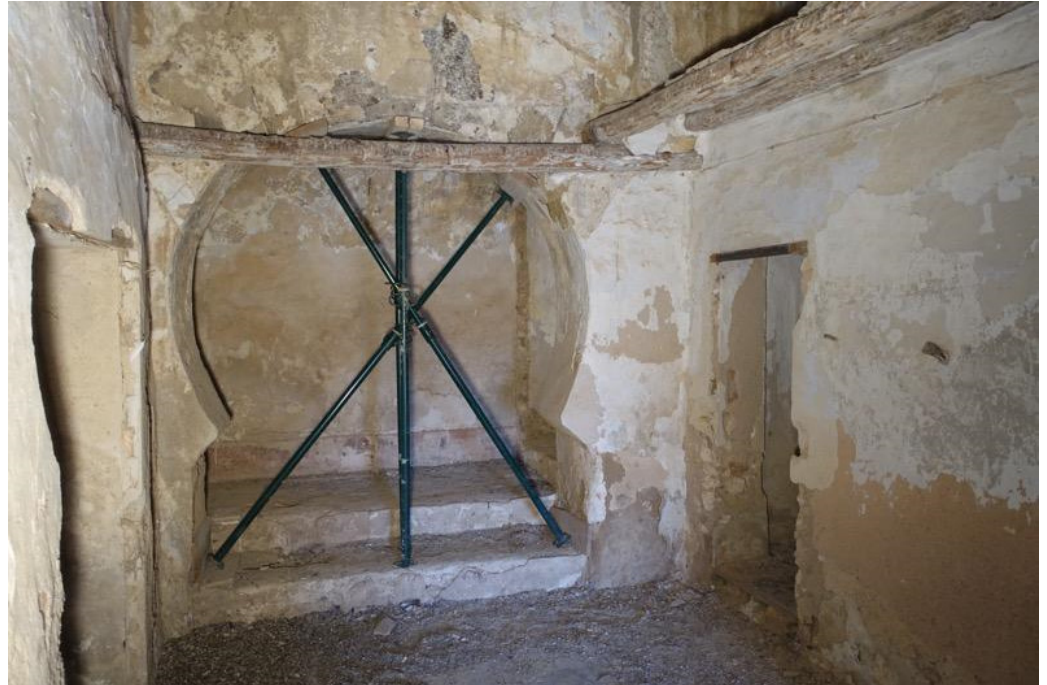
**Figure 13.** Western arch of the preserved pair from the arcade opening onto the central courtyard (Phase 3, A102, SU1092) and later modifications for domestic use, specifically the repair of springers and insertion of steps (Phase 6, A119, SU1093, 1094).

The outer, or northwesternmost arcade (SU1092, Figure A9), which functioned as an open façade onto the central courtyard, is preserved only in its two arches at the northeastern end (Figure 13). These exhibit the same characteristics as the interior arcade and bond with the northeast façade wall (SU1041), once again confirming the contemporaneity of the perimeter wall of the hall and the arcade façade. No traces of springers or perpendicular walls are visible on this same northeast wall (SU1041) that would suggest the existence of a third northwestern nave. It can therefore be assumed that the mosque hall was organised into two bays or naves, parallel to one another and to the southeast façade wall (or *qibla* wall). The arches, in turn, created eight naves perpendicular to this southeast wall.

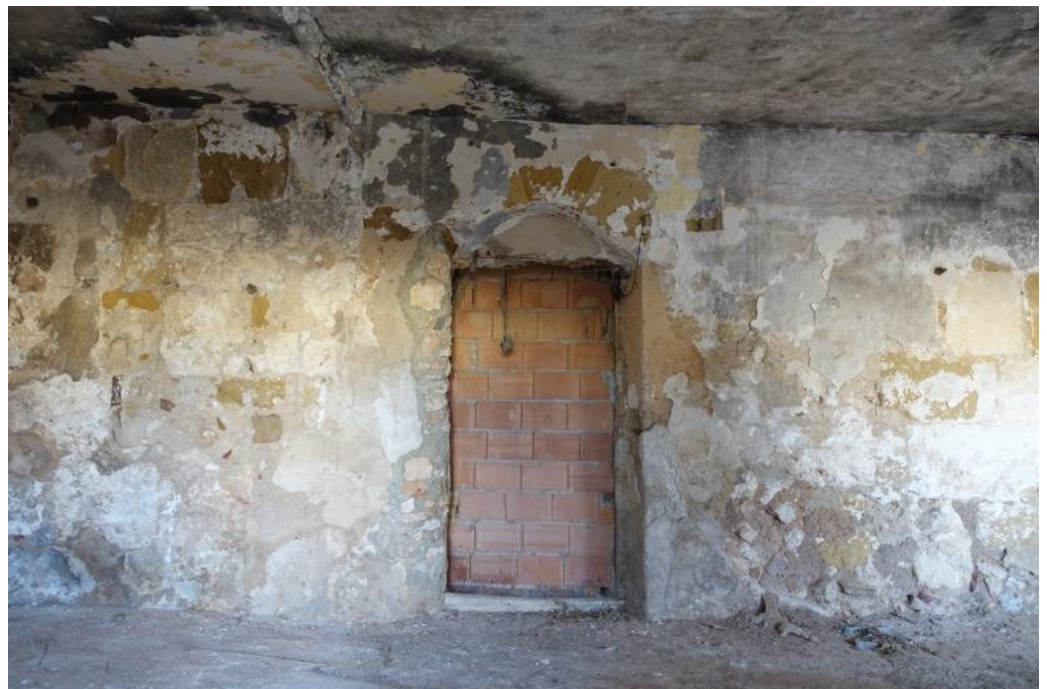
**Figure 14.** Arch belonging to the *mihrāb* (Phase 3, A102, SU1001). For stratigraphic sequence see Figure A5.

The definition of the mosque's configuration is completed by the identification of another series of distinctive elements. First, on the same southeast elevation (SU1001, Figure A1), between the fourth and fifth buttresses (counting from the east), there is an arch opening towards the interior of which the six sandstone voussoirs forming the upper third are preserved (Figure 14). Both the springers and the jambs have been lost on both the interior and exterior sides, meaning that the complete layout of the arch remains unknown. The current span measures 1.17 m, and the arch was framed on the interior by an *alfiz*, as indicated by vertical rebates in the lateral ashlar, spaced 2 m apart. The horizontal rebate is not preserved. The keystone is monolithic, and the arch ring reaches a thickness of 45 cm. Beneath successive layers of whitewash that partially conceal it, several well-dressed voussoirs and fine joints filled with white, lime-rich fine-grained mortar can be observed. These voussoirs appear to be bonded. On the exterior (Figure A1), the arch is not visible, and successive repairs to this area—above all the opening of a later passage in this location (Phase 6, A120, SU1009)—prevent the recognition of further original elements, apart from two ashlar with chipped faces. In the image published by Gozalbes Cravioto [2] (p. 55), the wooden shutter that closed this opening until quite recently can

still be seen. These would have belonged to the side walls of the *mihrāb* chamber, as suggested by the presence of the *alfiz* arch. This feature and the space associated with it appear to be notably off-centre with respect to the length of the *qibla* wall, although they are located very near to the southeastern space previously described. The function of this latter space will be revisited below.

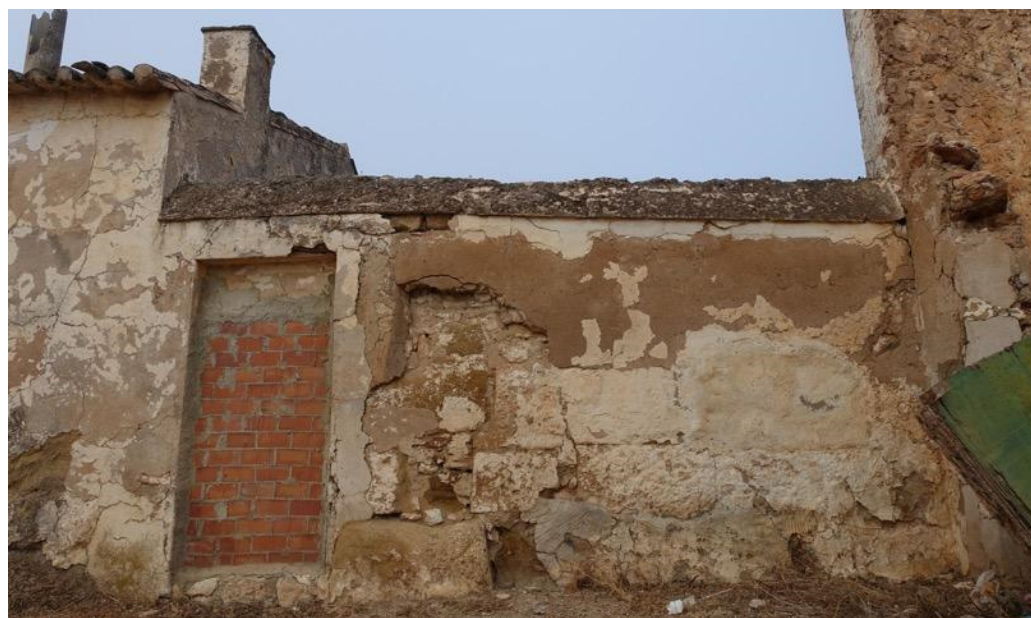
**Figure 15.** Remains of the jamb of the doorway that opened onto the central courtyard (Phase 3, A102, SU1050, 1051); change in masonry technique (Phase 3, A103, SU1052), right; and collapse of the doorway (Phase 4, A111, SU1053). For stratigraphic sequence see Figure A4.

On this same southeast front (SU1001, Figures A1 and A5), between the sixth and seventh buttresses and almost adjoining the former, an opening is documented with a two-piece lintel, one external (38 cm thick) and the other internal (42 cm). Both display a lower rebate (16 cm thick), and the internal one also features an upper moulding. The reveals of the opening are chipped, but would have originally matched the thickness of the indicated rebates. Moreover, the masonry courses on either side—or jambs—do not align in height, pointing to the existence of an original opening, possibly a doorway. The continuity of the courses is re-established with the insertion of the lintel described. This opening was subsequently modified, meaning its original dimensions cannot be determined (Figure 9). However, its location in the *qibla* wall suggests there may once have been an area on this southeast side of the building still enclosed by walls and thus belonging to the mosque precinct. Otherwise, direct access to the prayer hall from outside the mosque compound would be difficult to explain. In addition to these elements, there appears to have been a doorway where the current entrance to the farmhouse is located on the northeastern front (SU1041, Figure A4), opening onto the central courtyard (Figure 15).

To the north of the possible northern jamb (SU1051, Figures A4 and A8), there is a change in masonry (A103, SU1052) of which only three interior courses are visible (Figures 15, 16 and A8). This elevation rests directly upon the geological substrate and has an approximate thickness of 85 cm. Unlike what has been described so far, this masonry employs right-angled ashlar blocks, cut with a square (not with a straightedge), regularly alternating stretchers and headers of sandstone and limestone, and laid in horizontal (not sinuous) courses, with heights ranging between 40 and 54 cm. No putlog holes or tool marks are visible as the surface is heavily eroded. The joints remain fine and are bonded with a white, lime-rich fine-grained mortar. Its junction with SU1051 involves a marked offset in the courses—a change which, together with the typological difference, suggests a second construction phase within the same original project.

The destruction (A109, SU1082, Figure A6) of the arcade (Phase 3, A102) that divided the hall is evidenced by an approximately horizontal break which, as already noted in the description of the supports, coincides with the horizontal line of the *alfiz*. That is, the fracture occurs at the structurally weakest point of the arcade—the transition from the broader pillars to the narrower arches. A similar process occurred in the northwest arcade of the courtyard (Phase 3, SU106) where the horizontal breaks (A110, SU1057, Figures A3 and A7) mark the loss of the pillars at virtually the same height (Figure 19). Only the vertical break (SU1058, Figure A3) of the possible minaret (Phase 3, A110) appears intentional (chipping; Figure 17). Finally, both the projecting jambs of the northeast doorway (Phase 3, A102) and the northeast wall from the second construction phase (Phase 3, A103) also show signs of ruin (A111, SU1053). These elements were later chipped again (Figure 15).

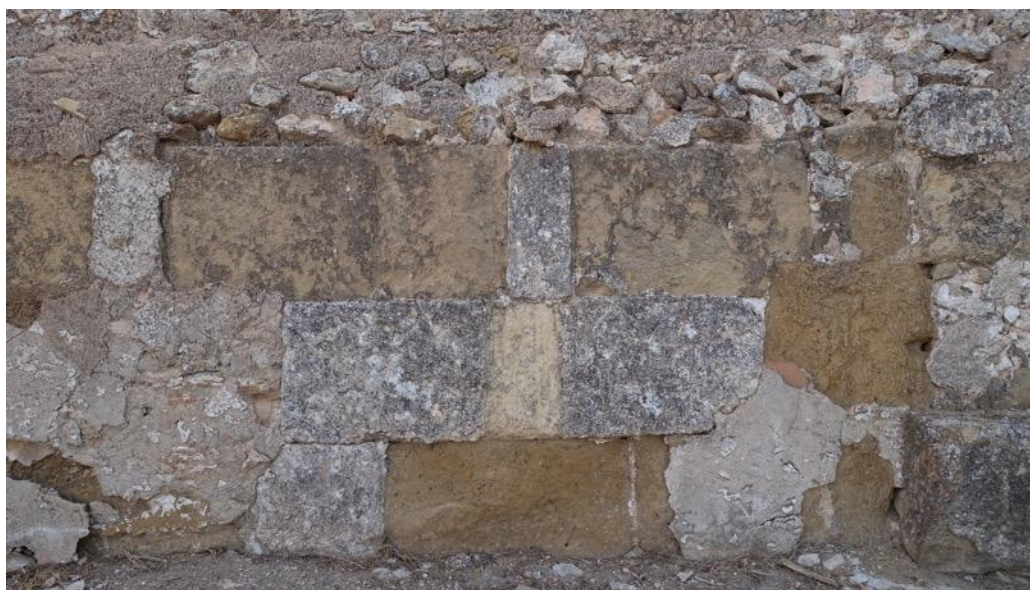
**Figure 16.** Interior of the northeast façade: regular masonry of stretchers and headers on the left (A103, SU1052) and junction with the earlier masonry on the right (A102, SU1051). For stratigraphic sequence see Figure A8.

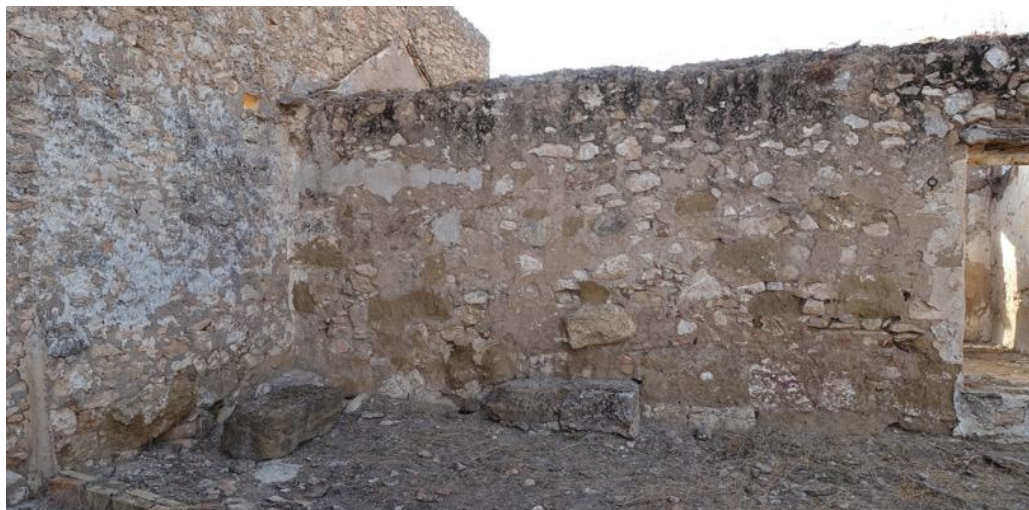
**Figure 17.** Blocks belonging to a possible structure (Phase 3, A154, SU1056, 1059); dismantling (Phase 4, A110, SU1058); and reconstruction work (Phase 6, A124, SU1066). For stratigraphic sequence see Figure A3.

Immediately afterwards, there are two structures of large stone blocks which may have formed an independent unit (A104; Figure 17), with a floor plan measuring  $3.60 \times 3.60$  m, but which are now isolated due to later cuts (Phase 4, A110, SU1057). The first (SU1056, Figure A3) consists of several blocks of similar height arranged in three courses (total height: 1 m), forming what would have been a southwest-facing façade. The lowest course rests directly on the geological substrate, assisted by wedges. The second (SU1059, Figure A3) is reduced to a single large stone block located at the northern end of this same northeast façade.

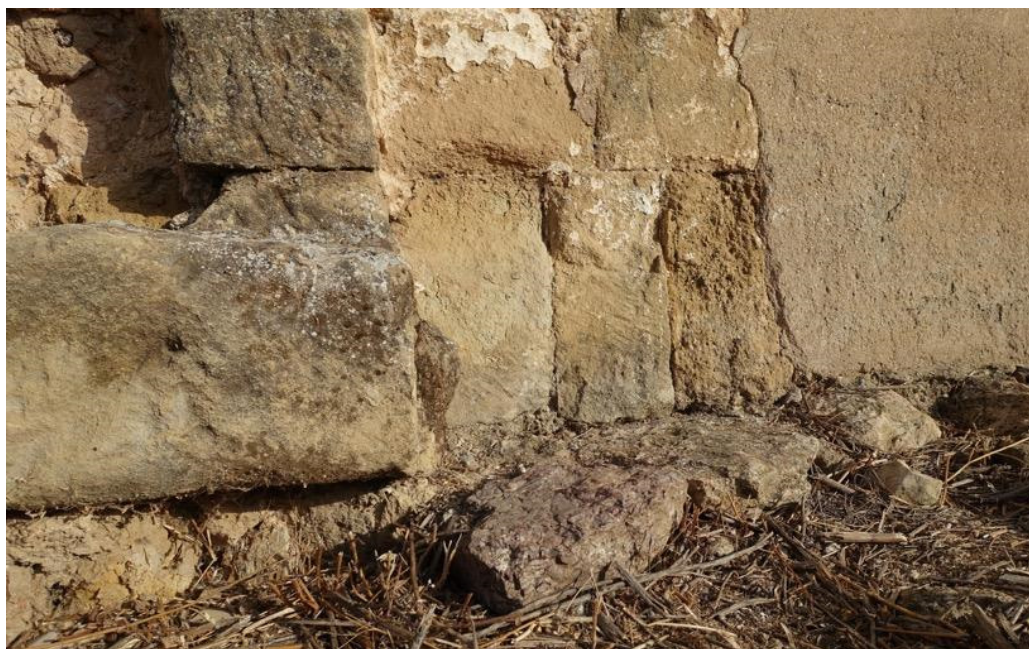
**Figure 18.** Blocks belonging to the preserved pavement in the corner of the northwest arcade (Phase 3, A105, SU1076) and detail of the ashlar masonry. For stratigraphic sequence see Figure A7.

In the western corner of the northwest arcade of the central courtyard, a fragment of paving (A105, SU1076, Figure A7) is located, composed of irregular blocks of white and violet/red quartzite, between 15 and 20 cm thick, which are tightly fitted together. These blocks form a regular, horizontal surface extending for a maximum length of one and a half metres and overlain by the arcade (specifically by pillar SU1064; Figure 18). For this reason, the floor must be considered contemporary with the arcade.

On all these supports, the ashlar masonry was designed using a square, ensuring the formation of completely horizontal courses (40–50 cm in height) without interlocking or additional adjustments between them (Figure 18). The blocks are systematically arranged in a stretcher-and-header pattern. The joints are extremely fine and filled with the same hard, fine white mortar that has been described throughout the structure. This mortar is sometimes spread across the face of the ashlar in bands no wider than 2 cm, thereby sealing the joints. Although the surfaces of the ashlar are heavily eroded, in less exposed areas it is possible to discern the use of an adze as the dressing tool, applied at a 45-degree angle. The pillars originally supported six horseshoe arches, the threads of which were narrower than the supporting elements, with the springers and first two voussoirs set horizontally.

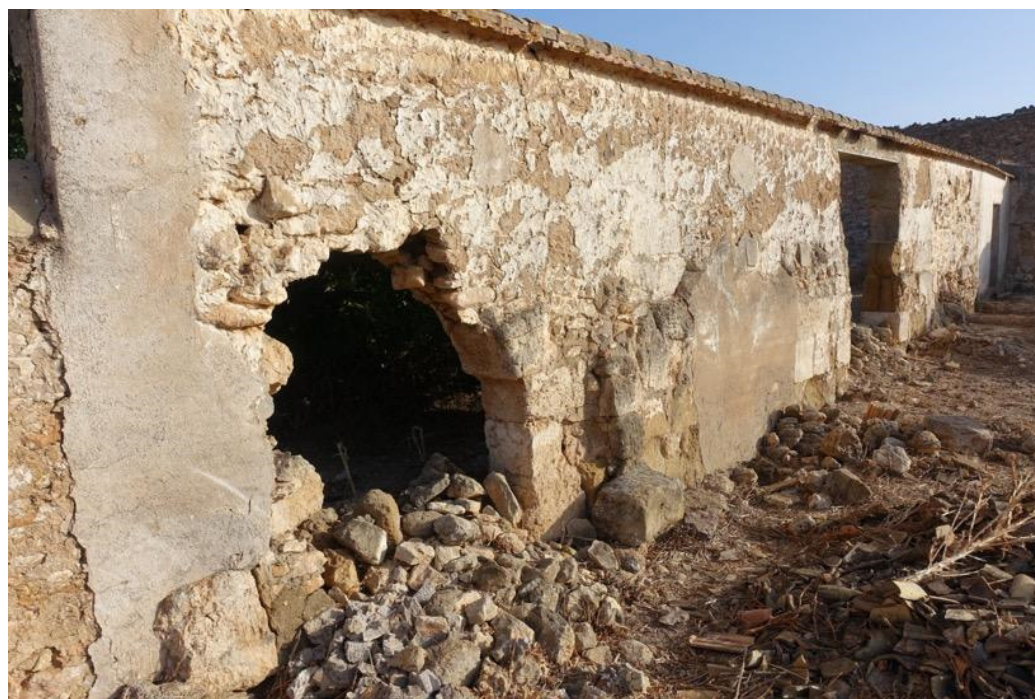
**Figure 19.** Northwest arcade (Phase 3, A106) seen from the south, with detail of the T-shaped pillar (SU1064) and horizontal break in the supports (Phase 4, A110, SU1057). For stratigraphic sequence see Figure A7.

The northwest arcade (A106, Figures A3 and A7), which encloses the central courtyard, is preserved in a fragmentary state and no complete arch survives (Figure 19). From east to west, the following supports have been identified:

- 2.10 m from the previous pillar is another (SU1064), 2.05 m in length, with a T-shaped internal plan and ashlar projecting to the southeast, which are now chiselled off. This detail suggests that a wall or arcade extended from this point, forming a southwest bay whose closing wall would align with—or perhaps correspond to—SU1025 (Figure A2). The lowest course again shows, on both sides, the lost lower step. The inner face of the pillar retains mortar identical to that described for arch SU1062, and this surface appears to have even covered the aforementioned step.

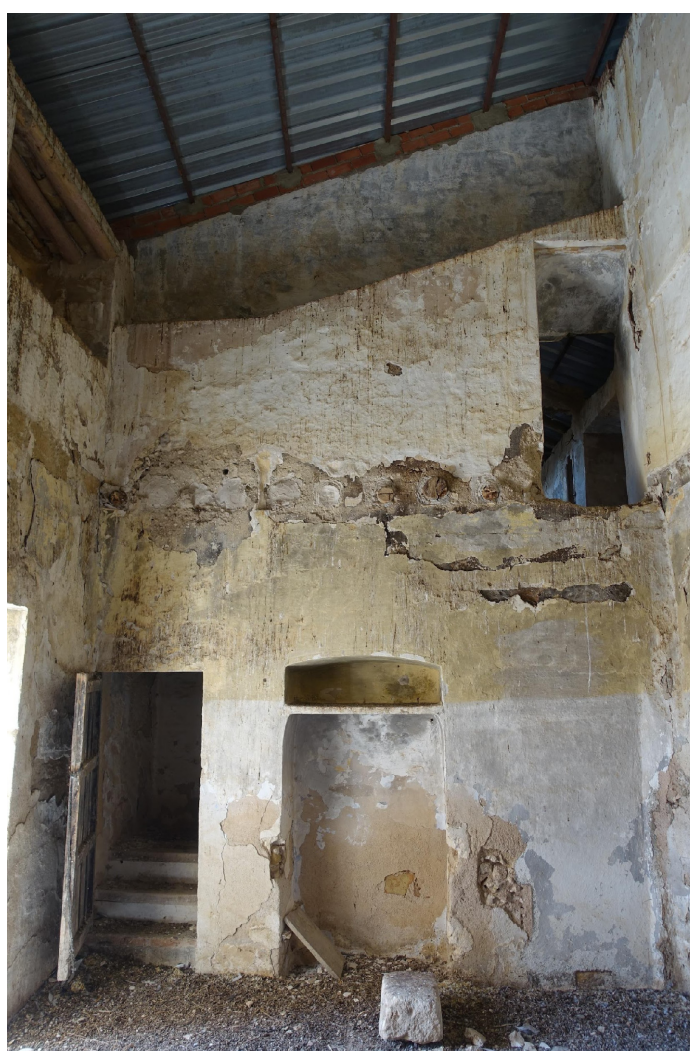
**Figure 20.** Partition wall (Phase 6, A112) separating the eastern and western sections of the original hall, upper storey added (Phase 6, A113), and blocking of the northern opening (Phase 6, A113, SU1095).

Possibly making use of the original partition that separated the eastern section from the rest of the prayer hall, a house was established in this southeast area, preserving the original division into two aisles (A112). For this purpose, not only a wall (Figure 20) but also masonry pillars (SU1097, Figure A6) were introduced, bonded with abundant rubble and lime-earth mortar and finished with earthen plaster. At the centre of this wall, a niche with a segmental arch and an upper shelf was created, revealing a wall thickness of approximately 55 cm. This feature would have functioned as a pantry for this room or kitchen, as suggested by the presence of a fireplace on the northeast side, i.e., on the opposite wall.

Above this structure, there is an upper section (SU1100) built of greyish earth and lime adobe with abundant small stone fragments. This continues into the northwest nave (SU1102, Figures 20 and A10), where it appears entirely whitewashed. Although the junc-

This house was subsequently expanded through the addition of an upper storey (A113; Figures 20 and 21). Adobe walls approximately one meter in height were constructed (SU1006, Figures A1, A5 and A6), featuring internal openings spanned by timber roundwood lintels. The western opening functioned as a cupboard, as indicated by the remains of internal shelving. The walls were finished with a solid brick cornice. This intervention created a new upper floor, intended for habitation, while continuing to rely on the earlier timber structure (A112, SU1022). This remodelling necessarily involved the raising of both the northeast façade (SU1023, Figures A4 and A8) and the southwest elevation, as well as the installation of a new, higher gabled roof. The northern end of the former northwest bay was subdivided into two rooms by the construction of narrow partition walls made of small-format masonry and reused ashlar, bonded with earth mortar (SU1091, Figure A6). The space was separated from the southeast bay by blocking the easternmost of the original arches (SU1095), using masonry bonded with lime and mud mortar, which also served as render (Figure 20). A second cupboard was inserted in the north face of this wall. All of the described walls are whitewashed, and their structural composition is visible only where the surface coating has deteriorated.

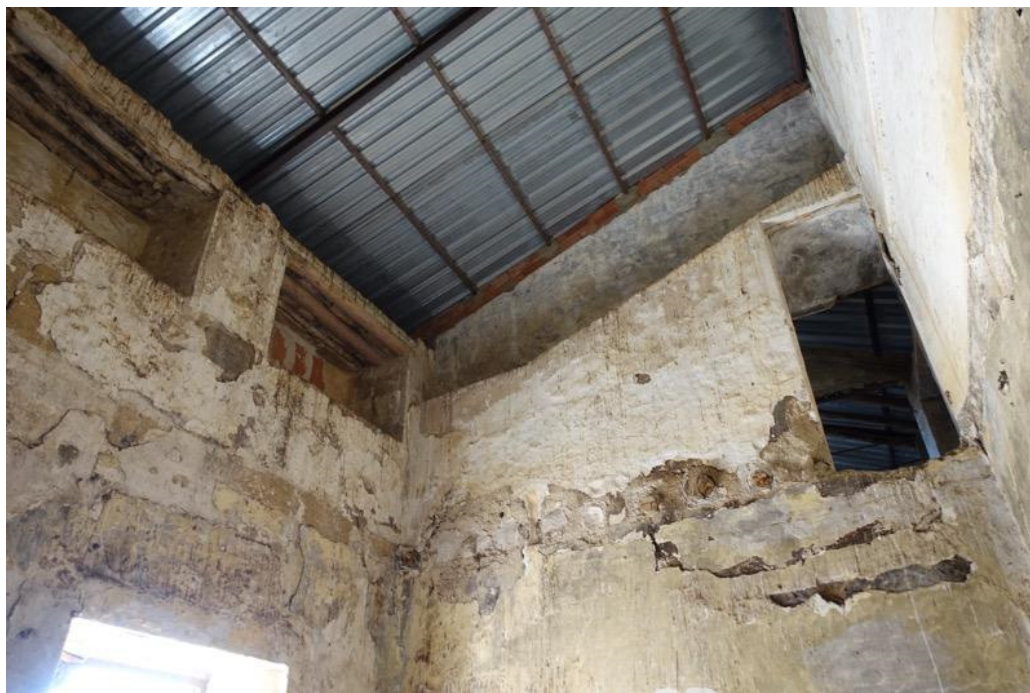
**Figure 21.** South corner of the second-floor elevation of the southeast house (Phase 6, A113).

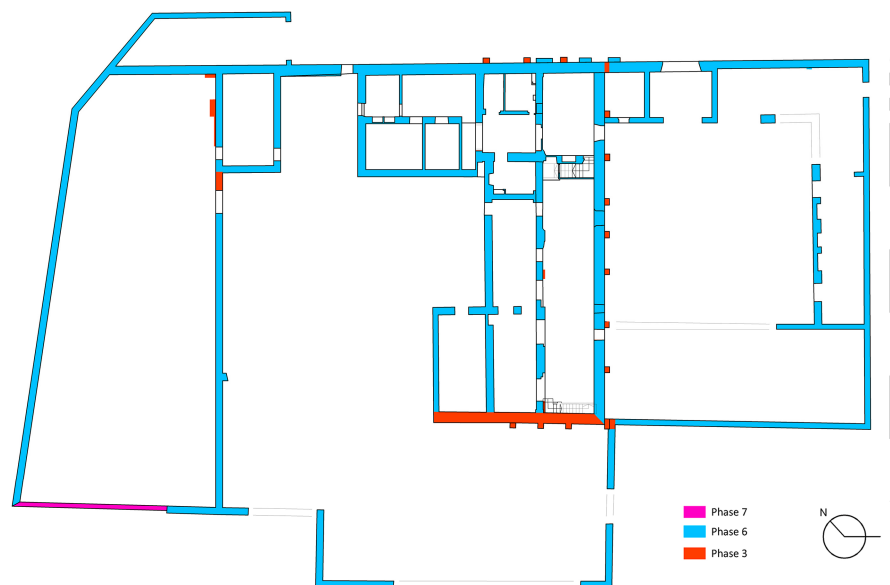
**Figure 23.** Plan of the preserved remains of the farmhouse (Phases 6 and 7) superimposed on the remains of the mosque (Phase 3).

In addition to this questionable documentary evidence, there remains a chronological gap in the materials studied from both the survey and the excavation [13]. For all these reasons, we consider Phase 6 to be dated to the nineteenth and twentieth centuries, during which the continued use of the farmhouse is reflected in various renovations which do not present typologies permitting a more precise dating (Figure 23).

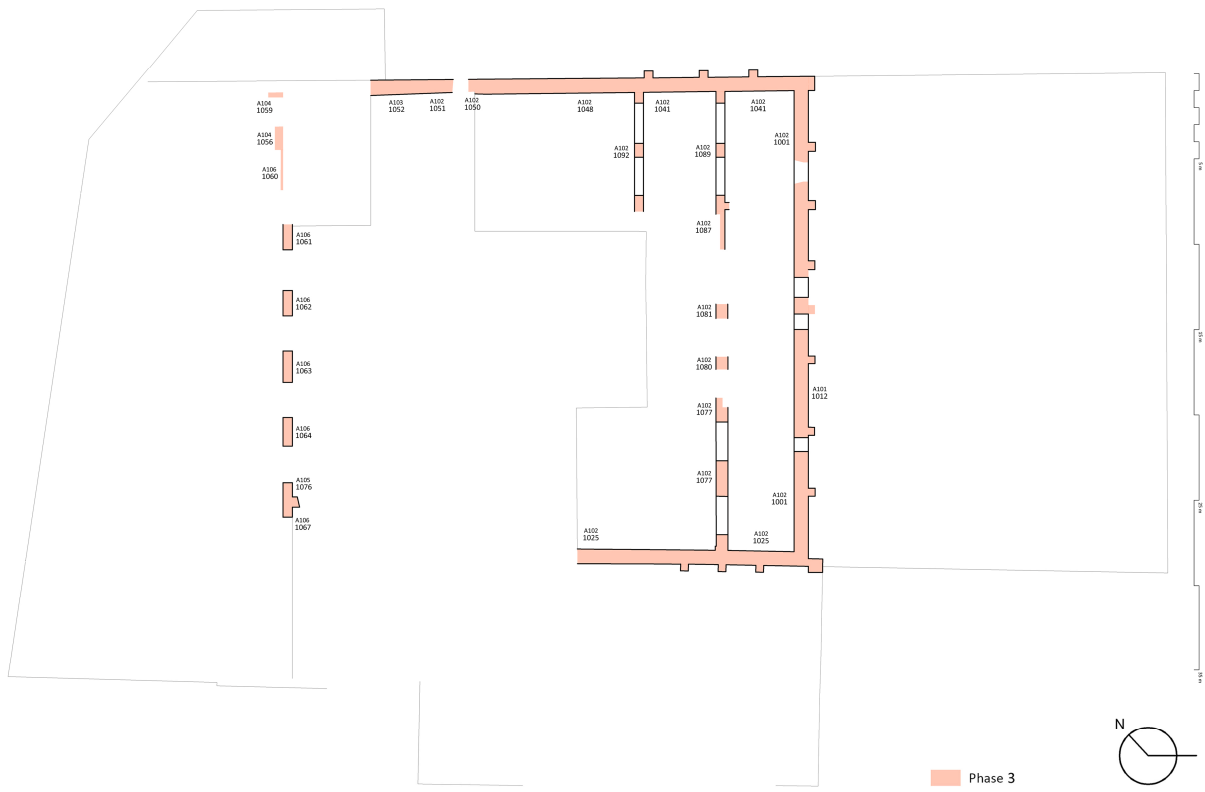
Figure A9. Plan of the sequenced structures in Phase 3.
